**ENVIRONMENTAL
CLAIM INVESTIGATION
FINAL REPORT**

OHES Ref: OHES_FJ5773 Clarach
Adjuster: Quadra
Adjuster Ref: 16256803
Insurer: Ecclesiastical Insurance Group
Insurer Ref: 405728
Insured: The Vicar & Chns FTTB & the PCC of Llangorwen in the Diocese of St Davids
Site: All Saints Church
Clarach
Aberystwyth
SY23 3DW
Report Author: Joe Rowland BSc
Environmental Consultant
Report Approver: Nick Tomlin
Regional Manager
Issue Date: September 22nd 2020

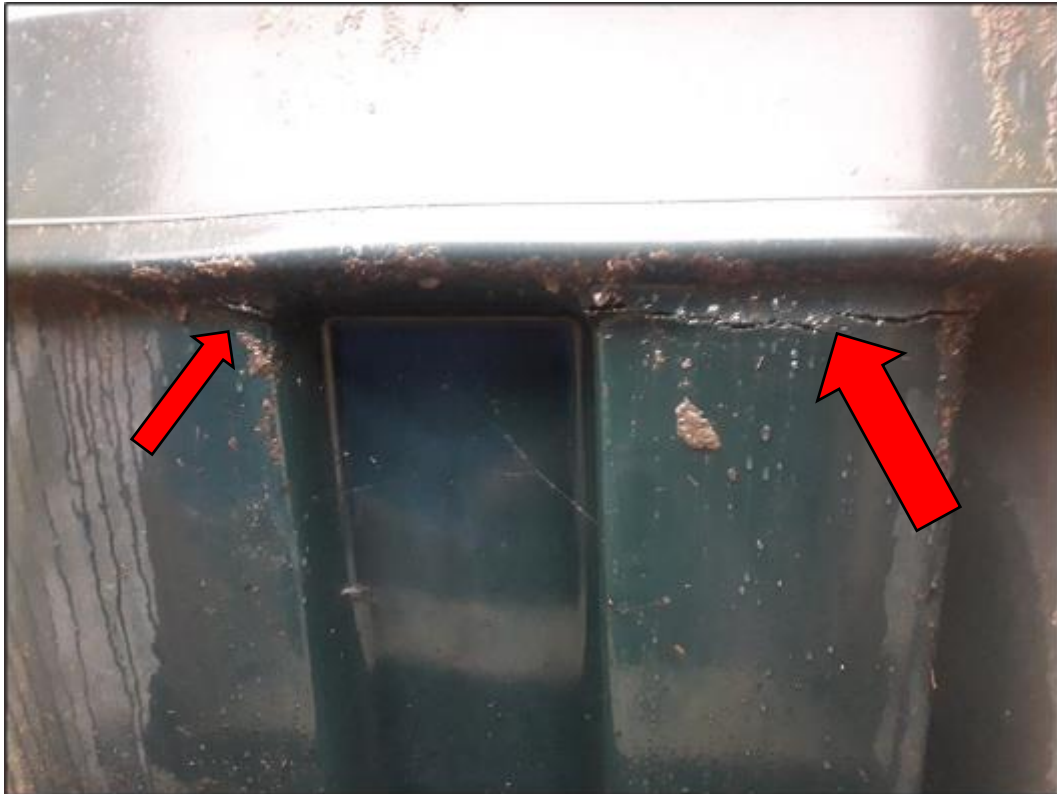
A strong kerosene odour was apparent close to the OST however it was difficult to inspect all of the OST given the surrounding wooden fence. Staining was apparent to the concrete blocks surrounding the OST and elevated volatile organic carbon (VOC) readings taken with a photo-ionisation device (PID) confirmed they had been impacted by oil. OHES removed panels from the fence to facilitate inspection of the OST - puddles of oil were apparent on the concrete surface beneath the raised OST base. Additional panels were removed revealing a large crack and multiple smaller surrounding cracks in the plastic OST approximately half-way up the structure (**Photograph 2**). The OST was observed to be bowed in its centre and bulging close to the crack (**Photograph 3**). Kerosene was dripping from the crack onto the ground below. The OST was almost full, with approximately 1,000 litres of kerosene above the crack.

Photograph 2 – Fence panels removed to reveal a large crack and smaller cracks in OST (18.06.20)

Given the volume of kerosene that could potentially be lost from a catastrophic failure of the OST, the risk of the OST failing at any moment and the sensitive receptors that could be impacted (**Photograph 4**) OHES deemed it necessary to instruct emergency response contractors, requesting immediate site attendance and equipment to facilitate a fuel transfer from the compromised OST.

Responders were contacted at 19:55 Hrs and arrived at site at 22:30 Hrs. During this time OHES placed a bucket beneath the crack to catch any kerosene and applied a clay patch to the crack. OHES conducted a brief air survey inside the church, no elevated ambient or point source readings were apparent. OHES removed the timber surround and checked the surface water drainage and the river for evidence of contamination, none was apparent.

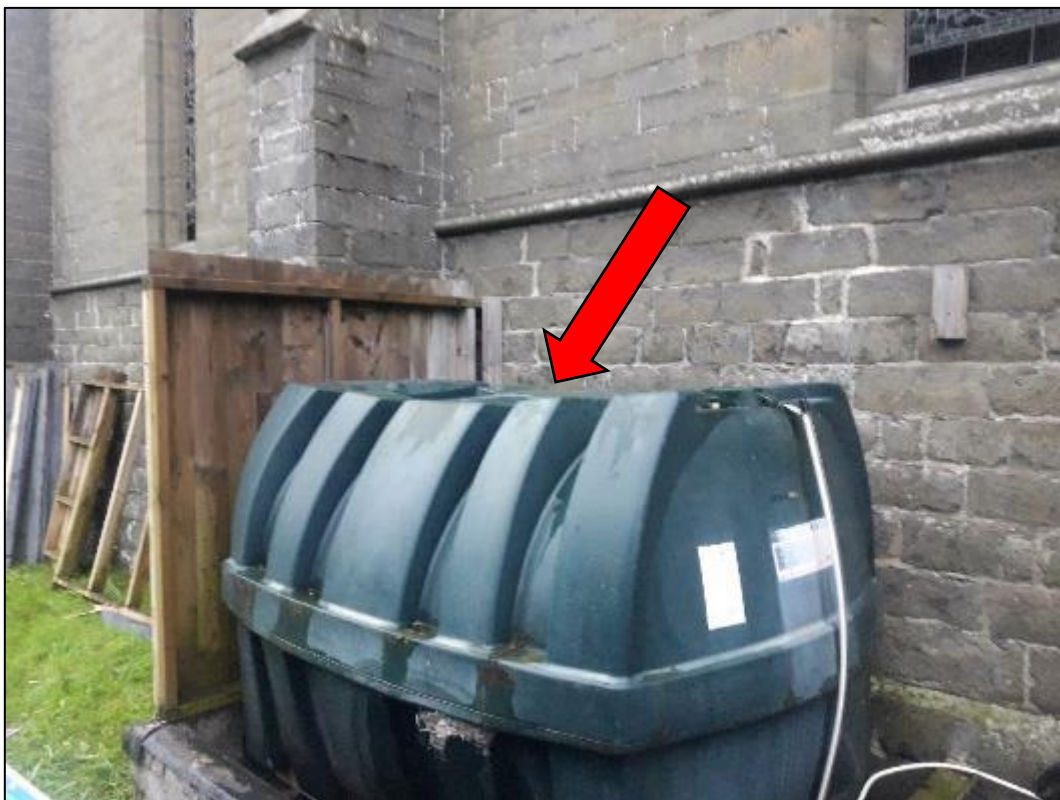
Photograph 3 – The OST was bowed in its centre and bulging close to the crack (18.06.20)

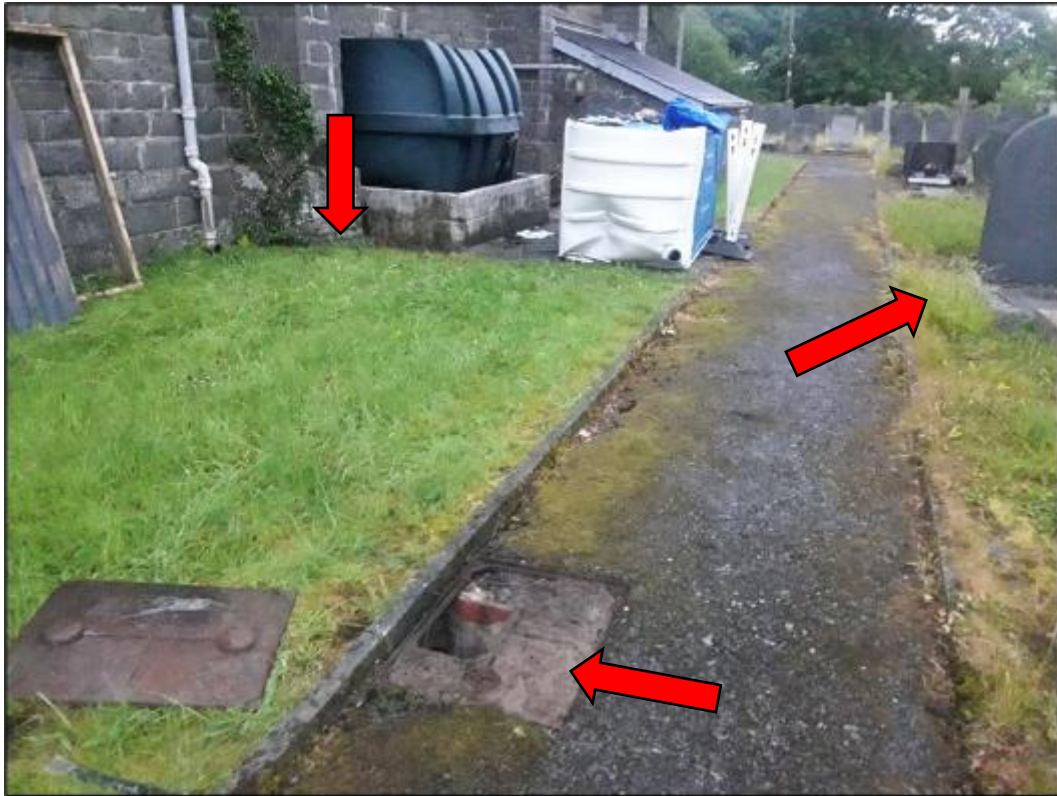
Photograph 4 – Sensitive receptors identified close to the OST; cemetery, surface water drainage and church structure (18.06.20)

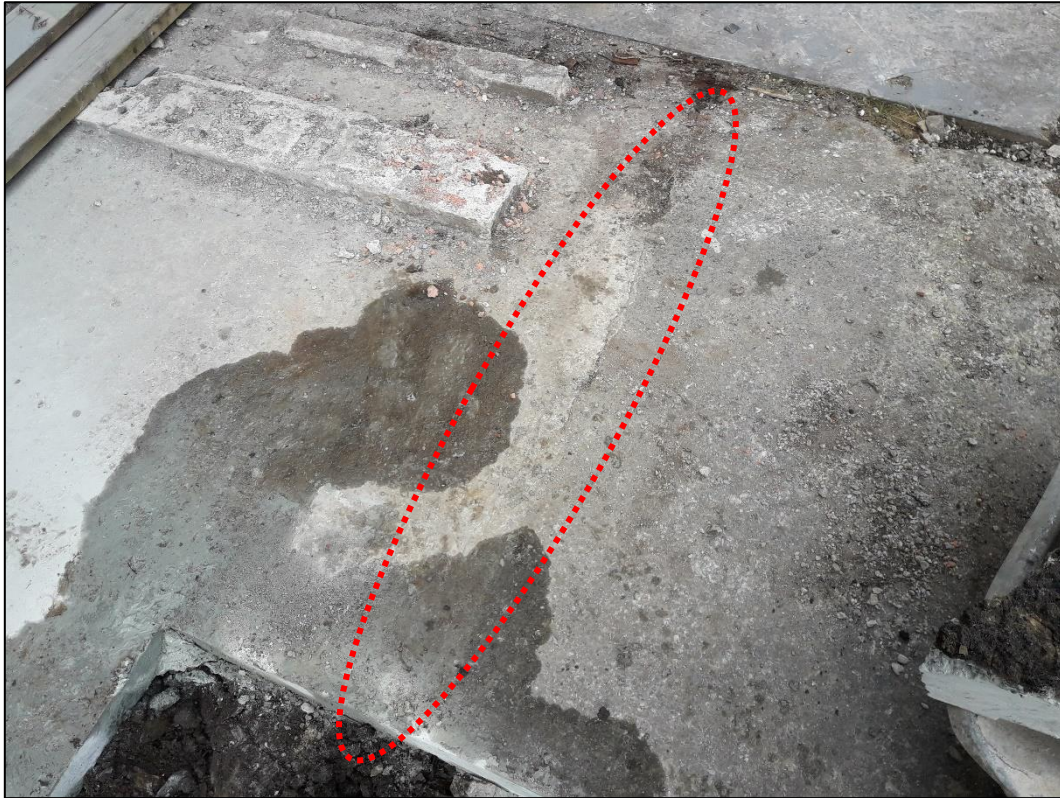
The original scope detailed that further investigation works would be required beneath the concrete slab to delineate the extent of contamination. Sampling works identified that a large area of soils beneath the concrete pad were contaminated by kerosene. It appeared as though a large crack in the concrete pad, which had initially been hidden by the concrete block bund had provided a pathway for the kerosene to migrate to soils beneath the concrete pad (**Photograph 5**).

Photograph 5 – Crack in the concrete pad allowed migration of kerosene to underlying soils (28.07.20)

The highest sample result returned was from location **V21 @ 1.0m** with a total TPH concentration of 16,364 mg/kg, this location is thought to have been directly beneath the crack in the concrete where kerosene had initially migrated. The excavation was terminated at a maximum depth of 1.25m due to the close proximity of the church wall, validation samples were retrieved from the excavation base. Base validation samples **EV8** and **EV12 @ 1.25m** returned concentrations below the LLD. Base validation samples **EV3**, **EV4**, **EV9 @ 1.25m** and **EV14 @ 1.0m** returned concentrations above the GAC's. Two samples were retrieved from beneath the base of the excavation in an attempt to delineate the vertical extent of the contamination plume.

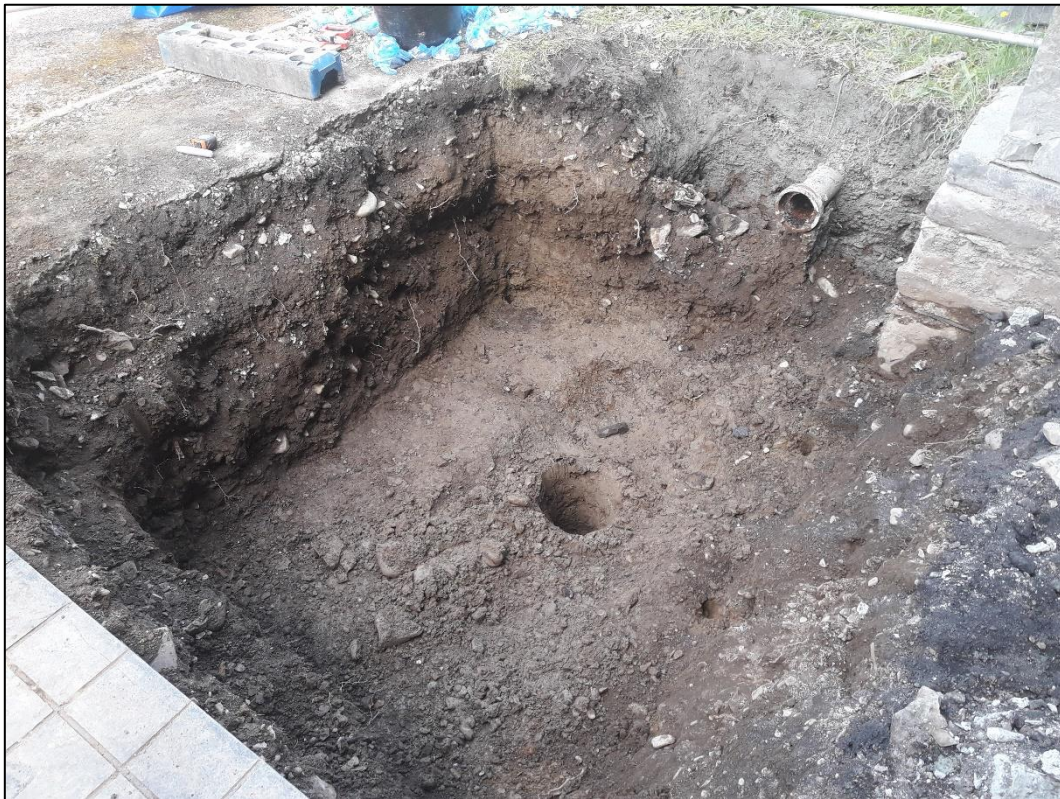
An area measuring 2.7m x 2.3m to a depth of at least 1.7m was found to be contaminated by kerosene beneath the concrete slab, this was in addition to the area beside the pad identified for excavation (1.3m x 0.7m to 1.0m depth) during the initial investigation. The excavation beneath the pad was advanced to 2.7m x 2.3m to 1.2m depth over this area (**Photograph 6**). Validation works identified that the sides of the excavation were clear of kerosene contamination. Contaminated soils remained in some areas in the base of the excavation.

Photograph 6 – Extent of excavation beneath the concrete pad (30.07.20)

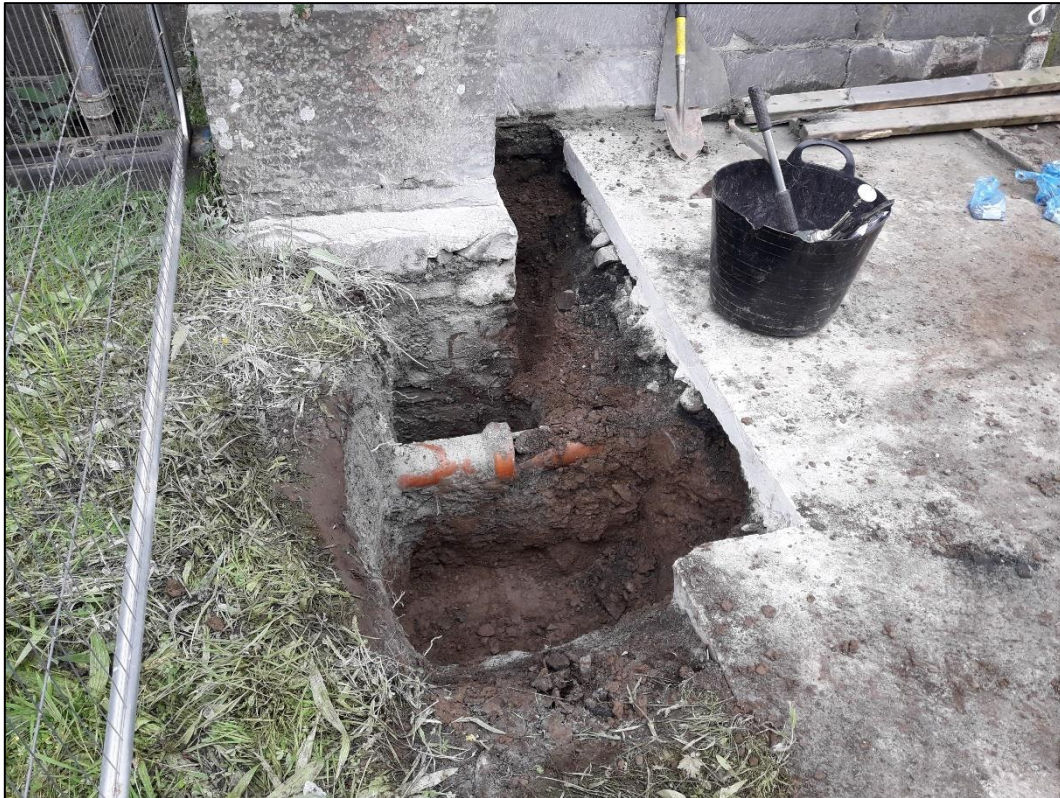
Based on the findings of the initial investigation, soils were initially excavated over the grassed area beside the concrete slab. Soil sampling was completed in tandem with excavation works in order to delineate the extent of kerosene contamination. An area measuring 1.4m x 0.6m was excavated to a depth of 0.85m beside the concrete slab and in front of the church wall buttress (**Diagram 2, Photograph 7**).

Photograph 7 – Concrete strip initially removed beside contaminated soils (27.07.20)

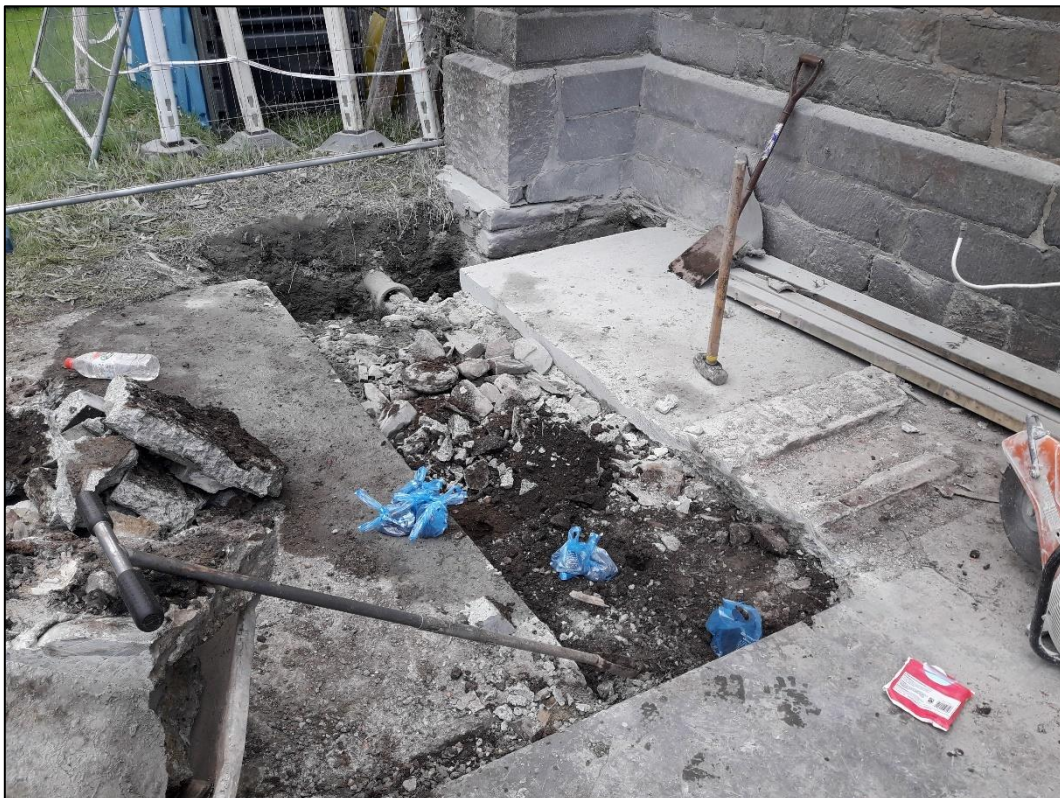
Photograph 8 – Concrete strip broken out, tracking contaminated soils beneath (28.07.20)

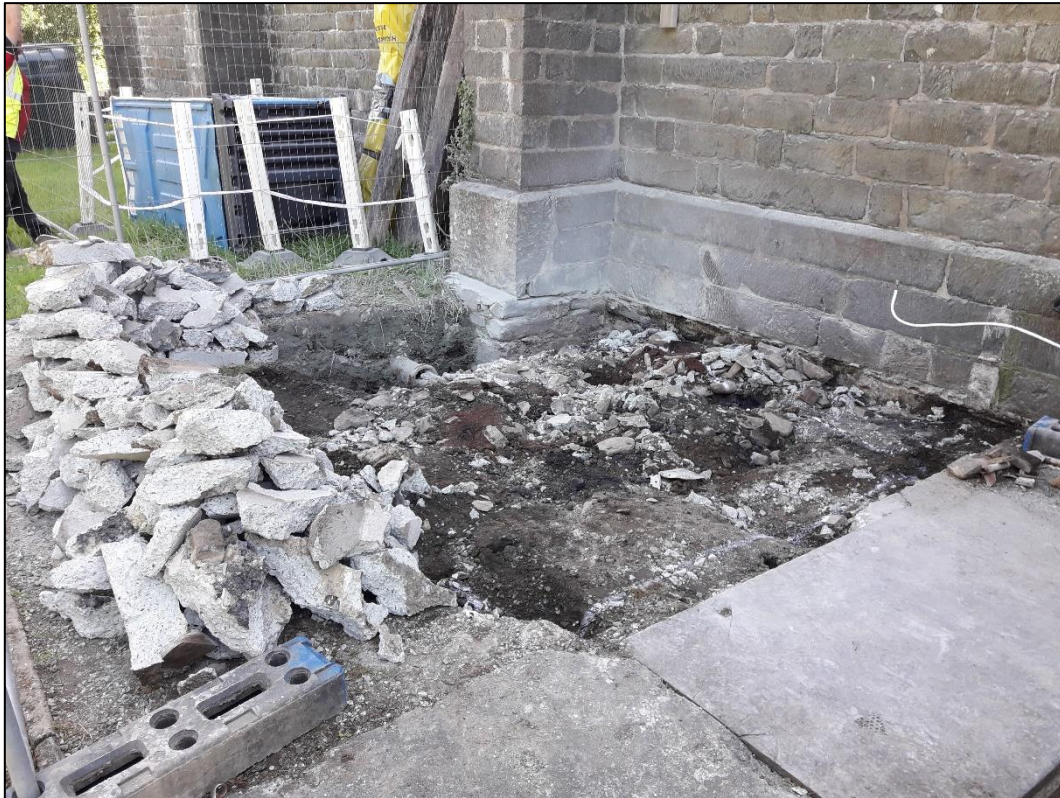
The wooden fencing, breeze block wall and OST base had been removed during the emergency response phase. A 0.5m strip of the concrete slab was cut out over a 2.5m length directly beside the grassed area highlighted as requiring excavation (**Photograph 7**). Soil samples were obtained and an appropriately calibrated PID was used to field screen these samples for the presence of VOC's. The readings obtained informed further investigation works. Soil samples from under the slab were found to be displaying elevated VOC readings, suggestive of kerosene contamination. A small crack in the concrete slab was identified (**Photograph 5**) and a 0.8m wide strip of the concrete cut out along a 2.5m length of this crack (**Photograph 8**). The crack appeared to be positioned where the small concrete bund wall previously sat around the OST. Soil samples retrieved from beneath the removed concrete indicated gross kerosene contamination, extending both laterally and vertically from the surface soils. A wider area of the slab was broken out, extending up to the church wall. The total area of break-out was 2.7m x 2.5m (**Diagram 1, Photograph 9**).

Photograph 9 – Concrete pad broken out to allow the underlying soils to be assessed (28.07.20)

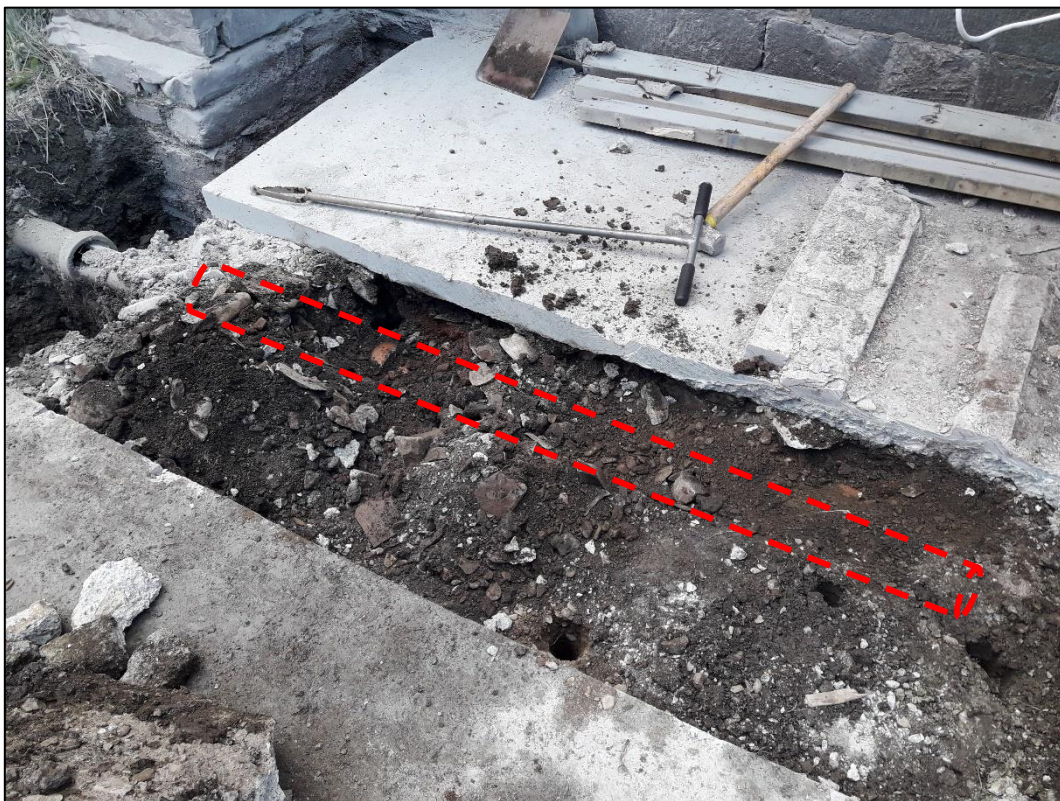
During excavation works, a redundant clay pipe was unearthed (**Photograph 10**). This was traced back during the excavation works and was found to terminate in the soil, with no apparent start point. A section of the pipe was found to be impacted by kerosene contamination. Sampling indicated that contamination had not migrated along the pipework. The church were consulted and as the pipe served no apparent function it was agreed that it could be removed.

Photograph 10 – Redundant clay pipe unearthed, route highlighted (28.07.20)

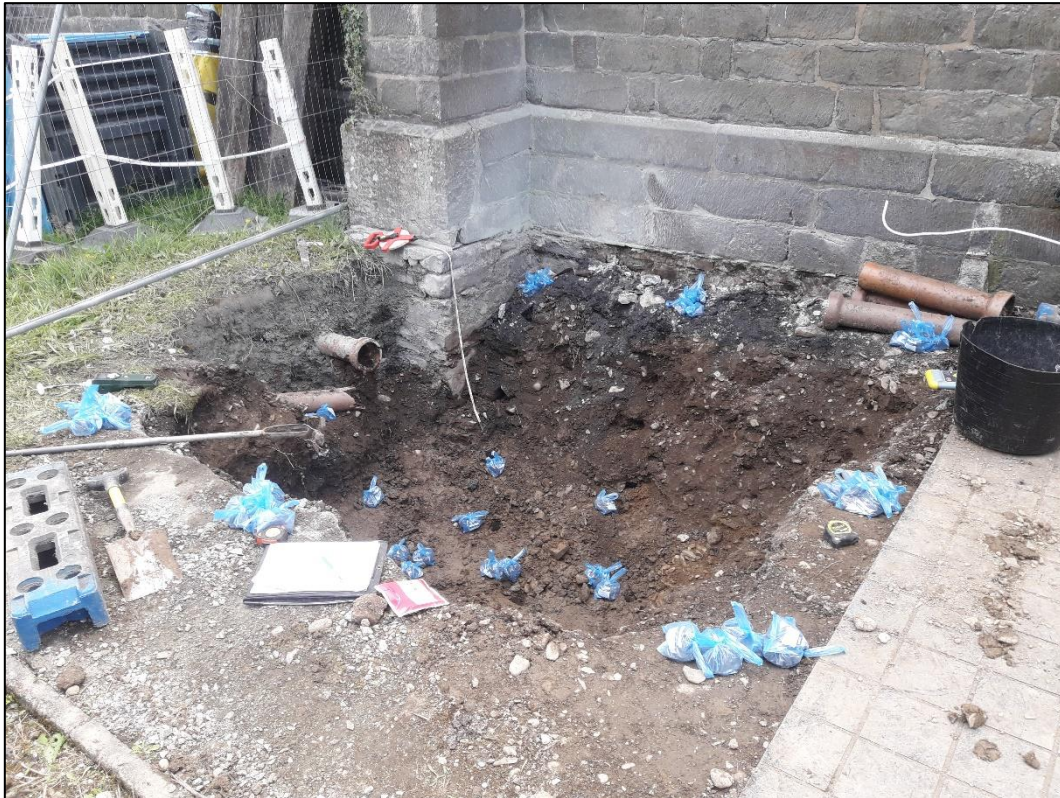
Photograph 11 - Soils were excavated over a 2.7m x 2.3m area to a maximum depth of 1.2m (30.07.20)

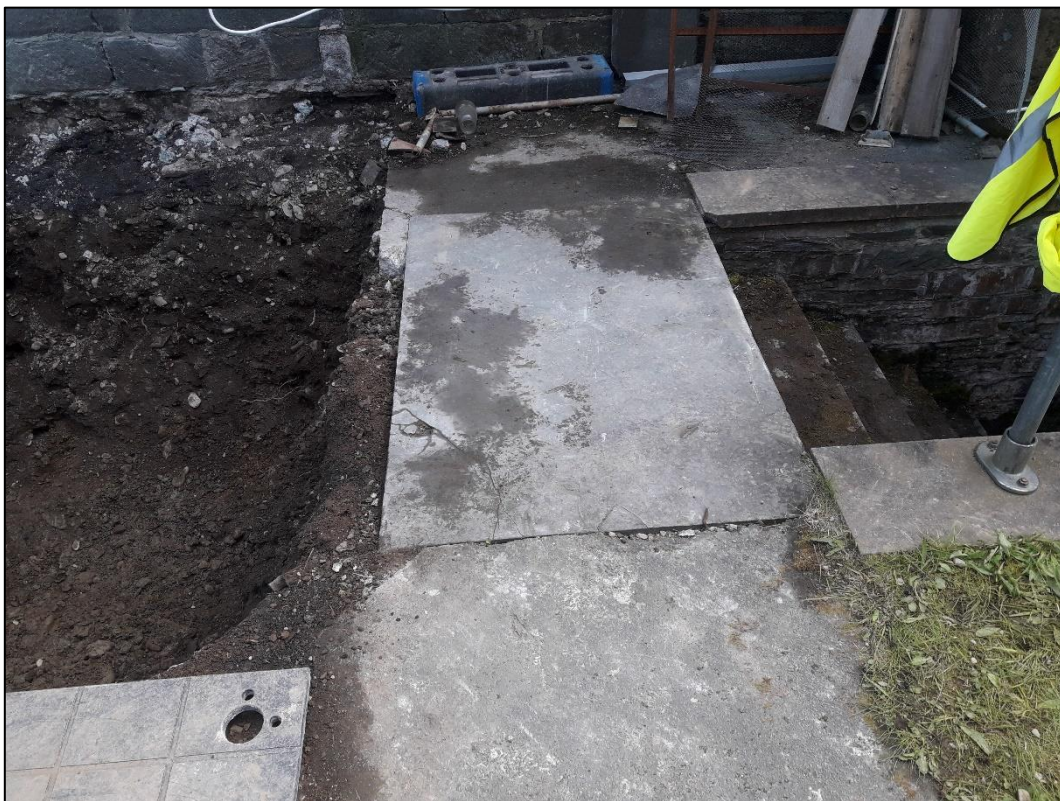
The large slate slab at the top of the stairs leading down to the boiler room had to be lifted to facilitate the additional excavation works. The slab was heavily cracked prior to lifting and broke up as expected. The church had been informed of this and were content for the slate slab to be replaced with concrete slabs to match those being installed for the OST base.

Photograph 12 – The slate slab had to be removed during remediation works (30.07.20)

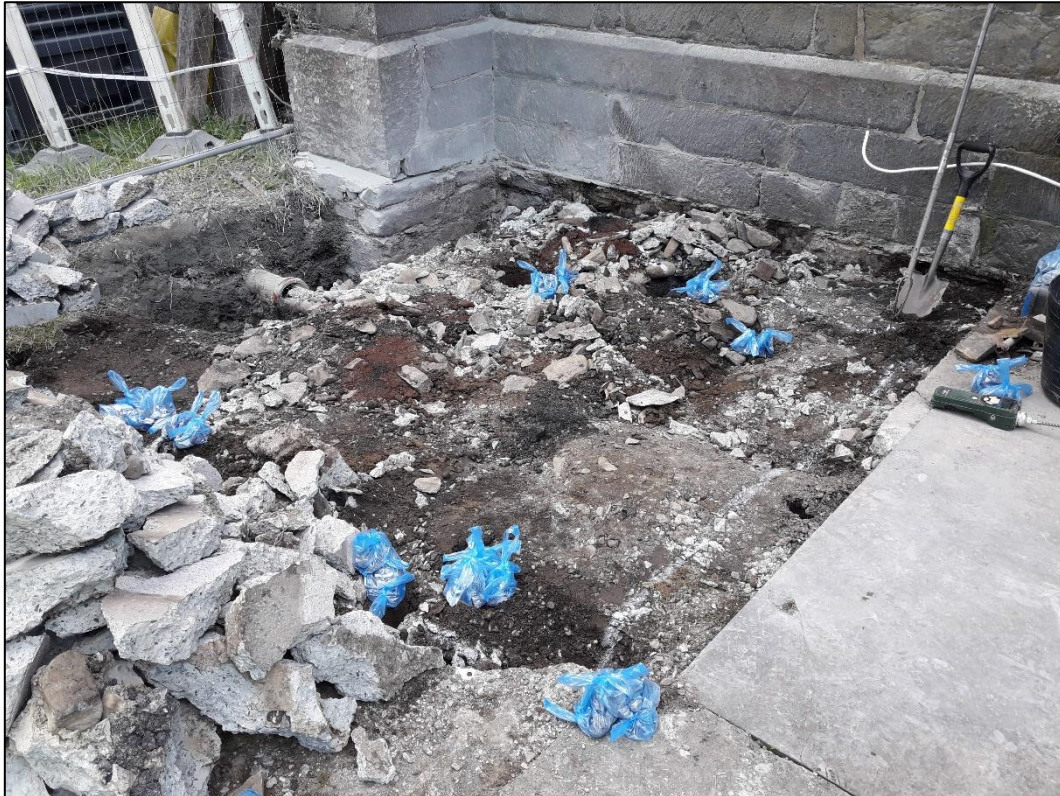
The **V** (validation) samples were retrieved prior to the mass excavation works beneath the concrete pad, the on-site PID readings from the V samples informed the excavation strategy. The **EV** (excavation validation) samples were retrieved following excavation works. All samples retrieved from the sides of the excavation returned results below the LLD. The excavation was widened to remove material at locations **EV3** and **EV4** in front of the slate slab as the sample results were found to be in exceedance of the GAC. The excavation was widened, to a maximum depth of 1.25m to sample locations **V23** and **V29** where results below the LLD had been returned. Samples **EV5 @ 1.1m**, **EV6 @ 1.0m** and **EV7 @ 1.25m**, taken from the face of the excavation between the POL and the church wall returned results below the LLD.

Photograph 13 – Validation (V) samples retrieved from beneath the concrete pad (28.07.20)

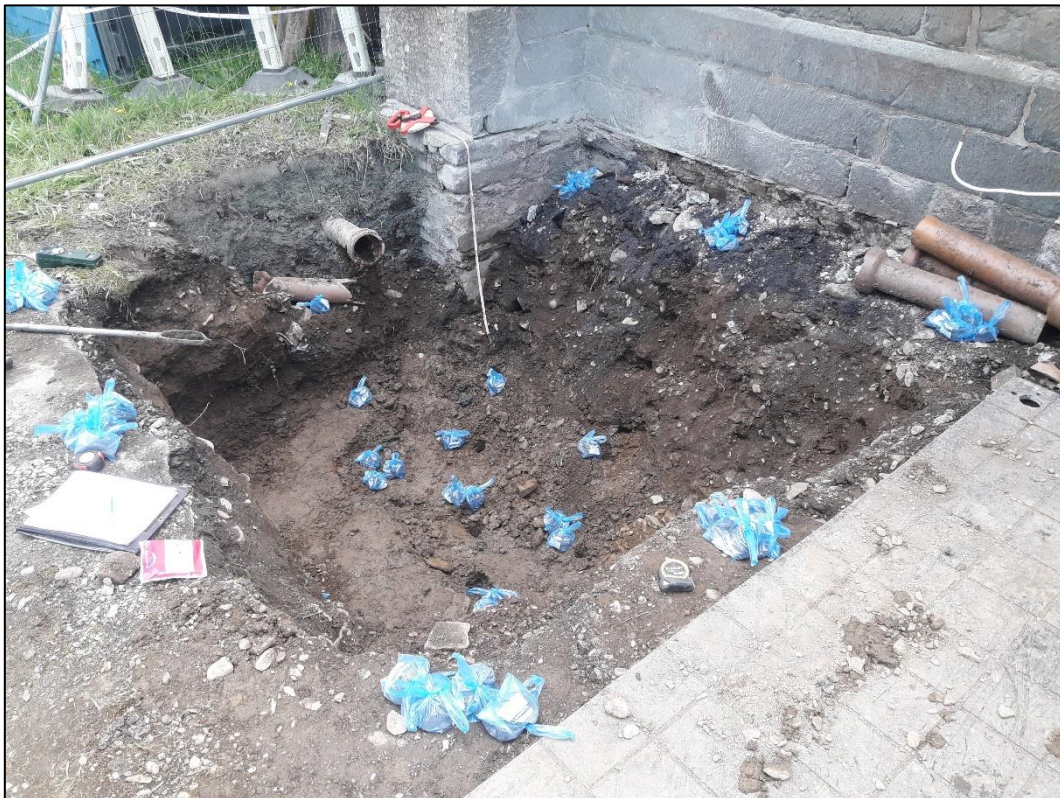
A maximum sample depth of 1.7m bgl was reached. Sample **EV11** and **EV13 @ 1.7m** returned exceedances of the GAC, however the total TPH concentrations for these samples (4,360 and 1,610 mg/kg) respectively were the two lowest concentrations out of the seven samples in exceedance of the GAC.

Photograph 14 – Excavation Validation (EV) samples retrieved (30.07.20)

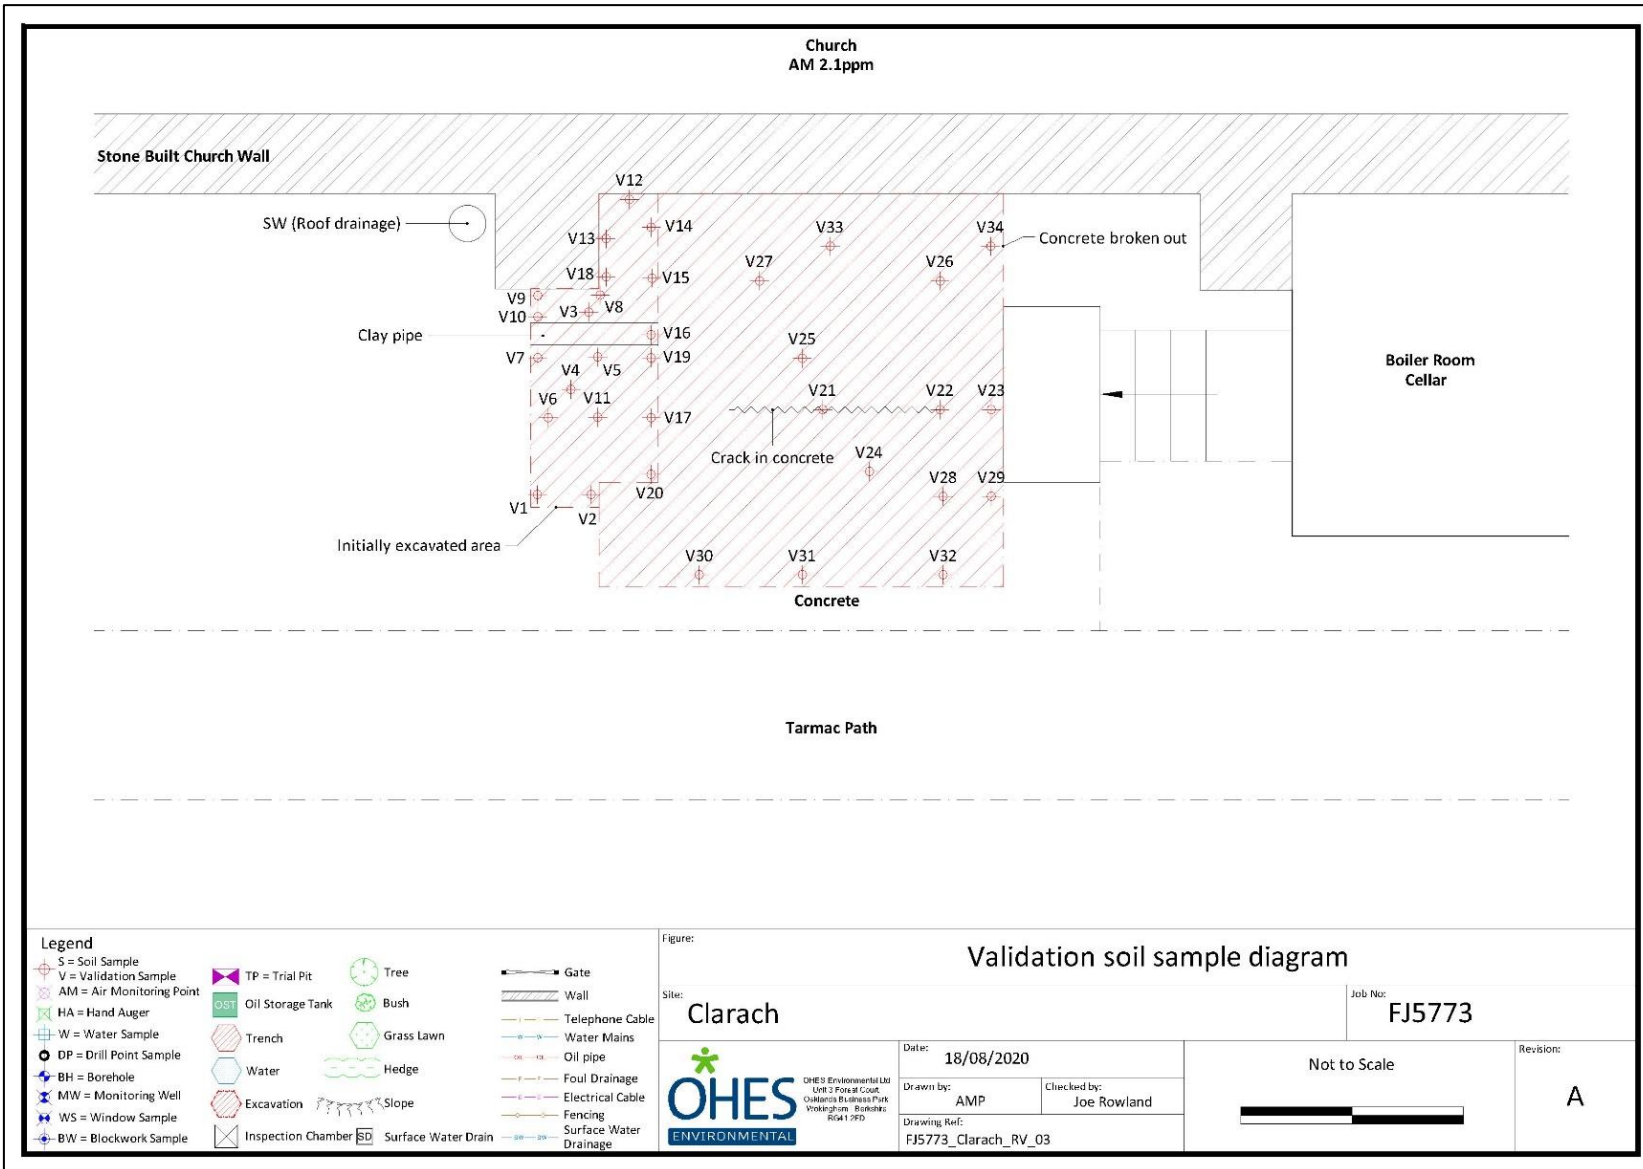
Diagram 1 – Validation soil sample diagram and area of concrete breakout

A total of 133 samples were obtained from 48 locations (designated **V1 – V34** and **EV1 – EV14** as illustrated in **Diagrams 1 and 2, Photographs 13 and 14**). An appropriately calibrated Photo-ionisation Detector (PID) was used to field screen these samples for the presence of VOC's.

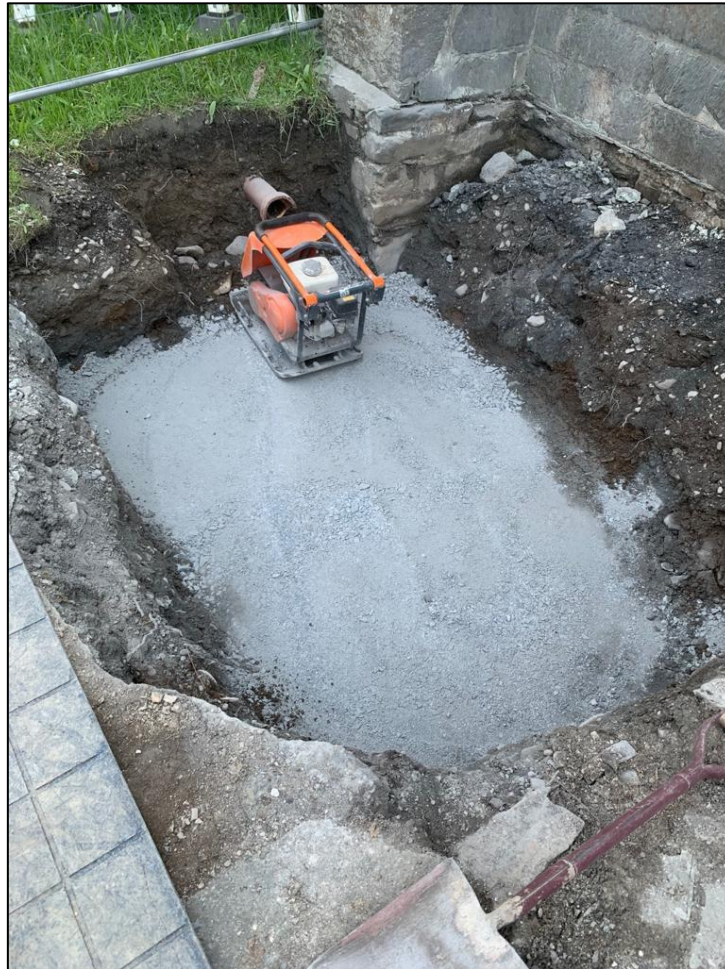
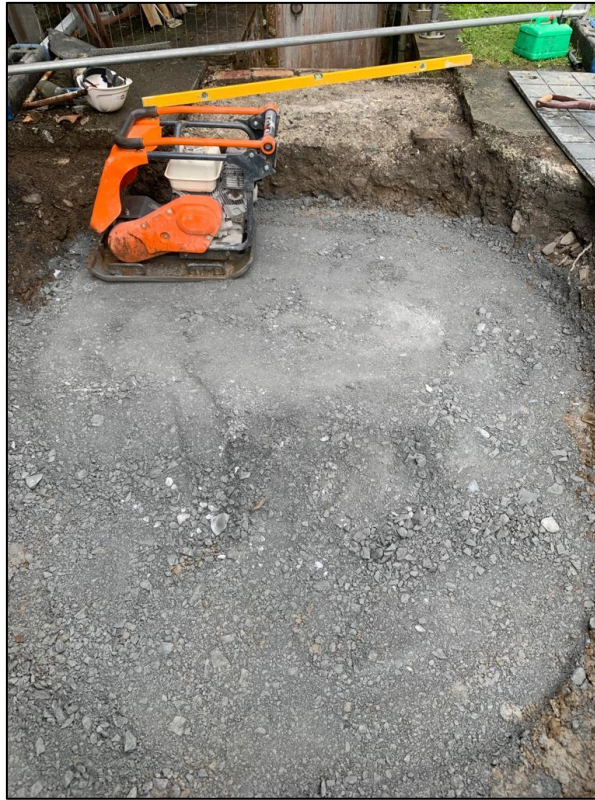
Photograph 15 – Excavation backfilled with MOT compacted in layers (12.08.20)

Photograph 16 – Excavation backfilled with MOT compacted in layers (13.08.20)

MOT was used to backfill the excavation and was compacted in layers to form a firm substrate (**Photograph 15 and 16**). The excavation was backfilled to ground level, concrete was removed up to the tarmac path and remaining concrete pad edges cut to form a clean face (**Photograph 17**). Concrete slabs were laid over the compacted MOT to form an OFTEC compliant tank base for the new OST (**Photographs 18 and 19**). The 50mm thick slabs were laid over the area previously covered by the concrete pad. Slabs were also laid at the top of the stairs down to the boiler room to replace the slate slab (**Photograph 19**). The Church purchased a new 2,500-litre, plastic, bunded OST to replace the compromised OST. The OST was positioned on the concrete slabs, ensuring that OFTEC guidelines were adhered to and a 1.8m distance was maintained from the church window (**Photograph 20**). A new FTL was installed, running from the OST to the boiler, the FTL was attached to the church wall to match the previous installation (**Photograph 21**). The heating engineer advised that it was not necessary to lower the height of the FTL on the wall as the fall to the boiler would be sufficient to keep a constant pull of kerosene to the boiler. A timber frame was constructed around the OST (**Photograph 22**), maintaining a distance of at least 0.6m between the OST and the frame as per OFTEC guidelines. Timber boards were fixed to the frame to match the previous 'feather edge' style fencing and were painted grey to match the previous colouring (**Photograph 23**). Topsoil was applied to the area of ground that had previously been grassed and was topped with grass seed (**Photograph 24**). The kerosene was transferred from the temporary OST's to the new installation on the 26th August and temporary OST's removed the following day. Due to a stoppage issue with the previous fire valve, which was preventing fuel supply to the boiler a new fire valve had to be fitted. Following this the boiler was successfully test fired. A 'Watchman' type electronic fuel measuring device was supplied with the new OST and the monitor plugged in, in the boiler room (**Photograph 25**).

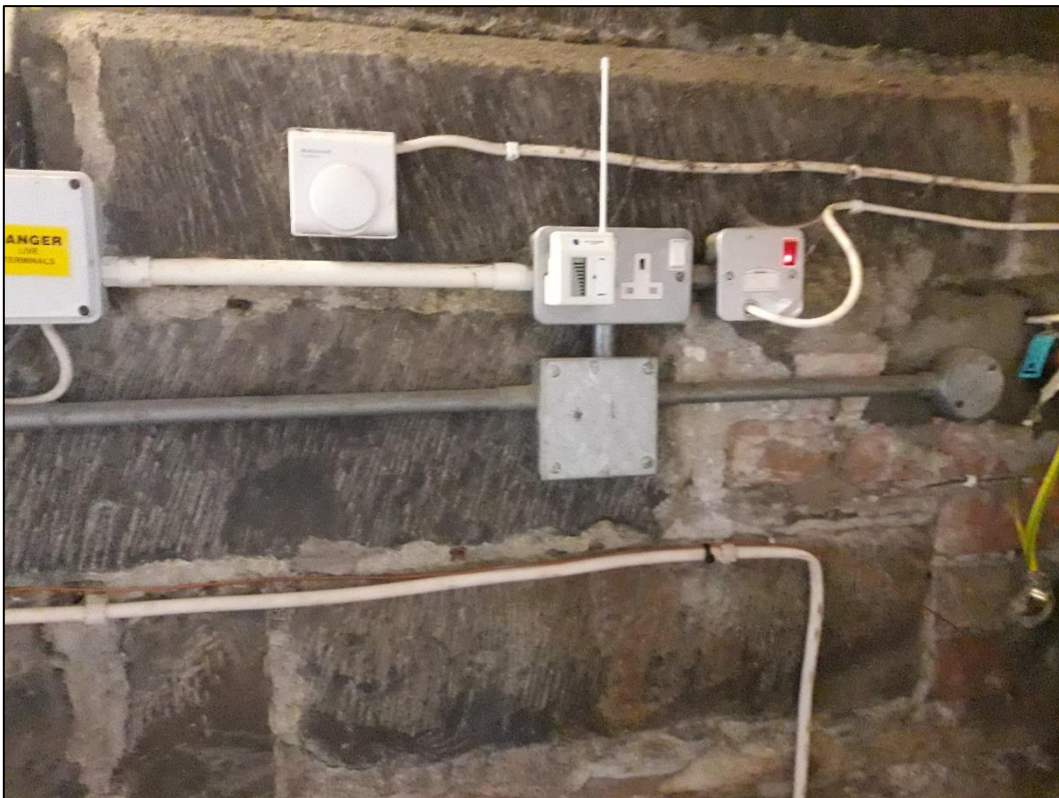
Photograph 25 – Electronic fuel level monitor in the boiler room (01.09.20)
